When Should a Towline Be Retired?

Chafe protection and twist and how to recognize their impact

Kris Volpenhein, Technical Support Manager
Robin Collett, European Sales Manager
Samson Rope Technologies, Ferndale, WA 98248, USA

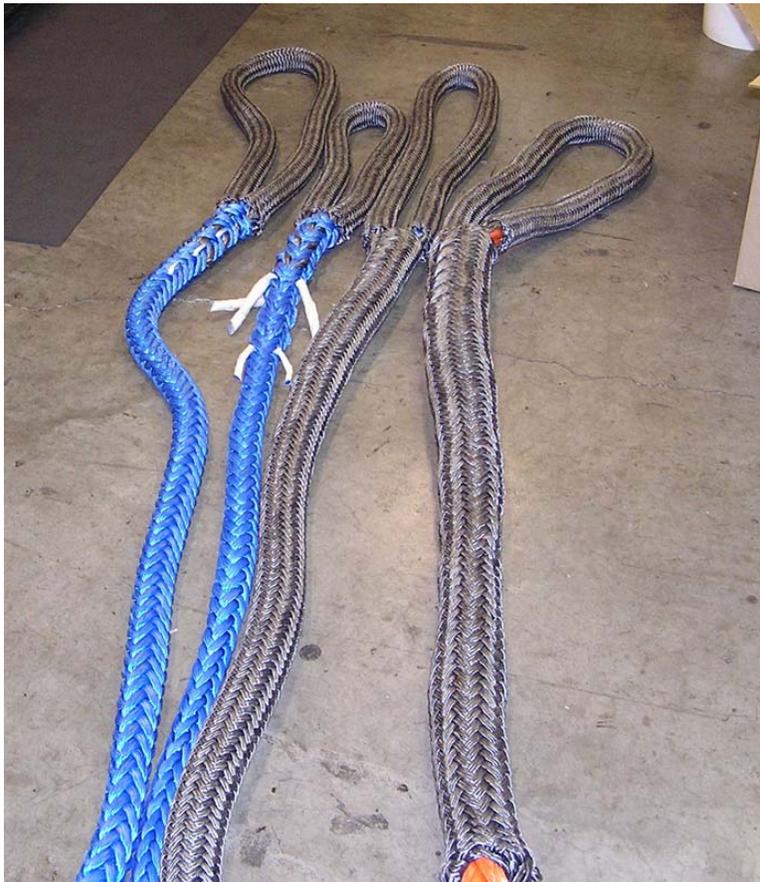
Figure 2 - Towlines with eye and body braided chafe gear

Figure 2 shows two typical towlines with a length of braided chafe gear along a section of the line (as well as within the spliced eye).

This configuration of chafe gear was used on a towing pendant installed on a 6,500 hp tractor tug. After approximately 1,300 assist jobs the line was retired and returned to the factory for testing and inspection. By visual inspection it is apparent the benefits that the chafe protection provide. Figure 3 shows the protected end of the line and Figure 4 shows the typical wear on the unprotected end of the line, both internal and external.

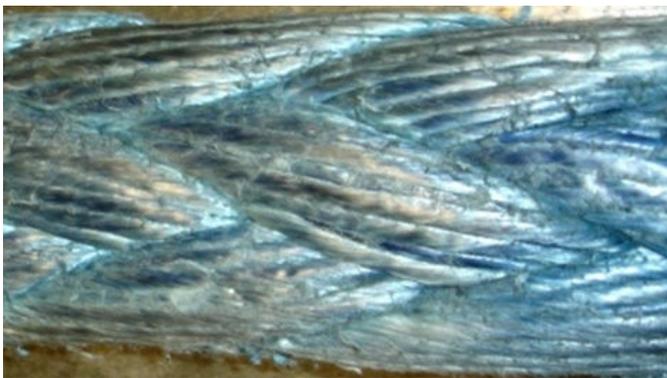
Figure 3 - Protected portion of pendant

While the protected end of the pendant showed little sign of serious damage and had a predicted residual strength of 65-75%, when tested the pendant broke at a load of 51% of the new rope minimum breaking strength and broke in the most severely damaged area.

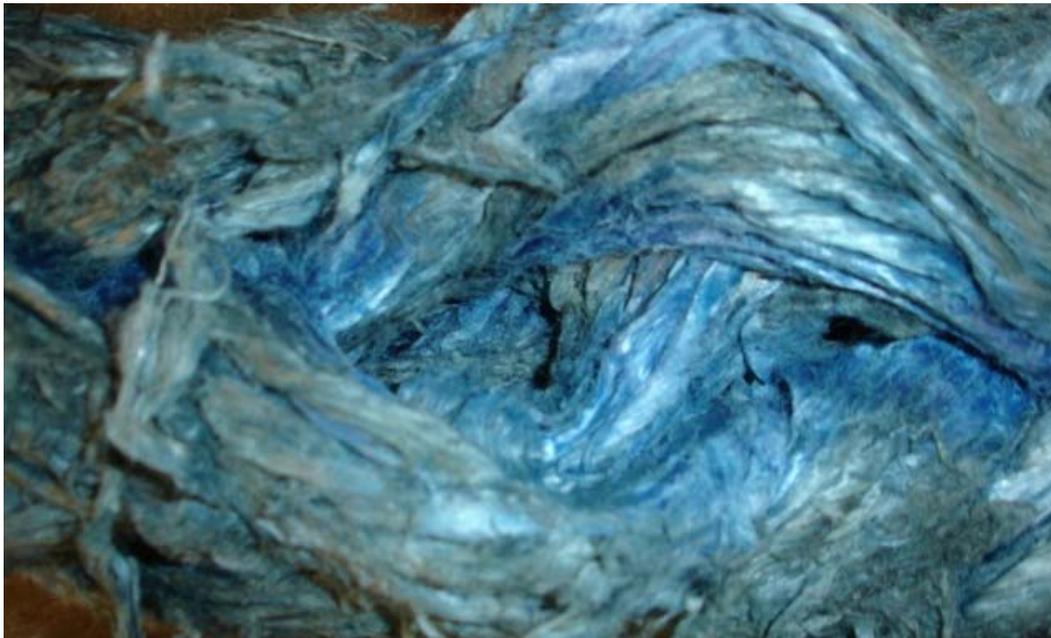
Figure 4 - Unprotected portion of pendant

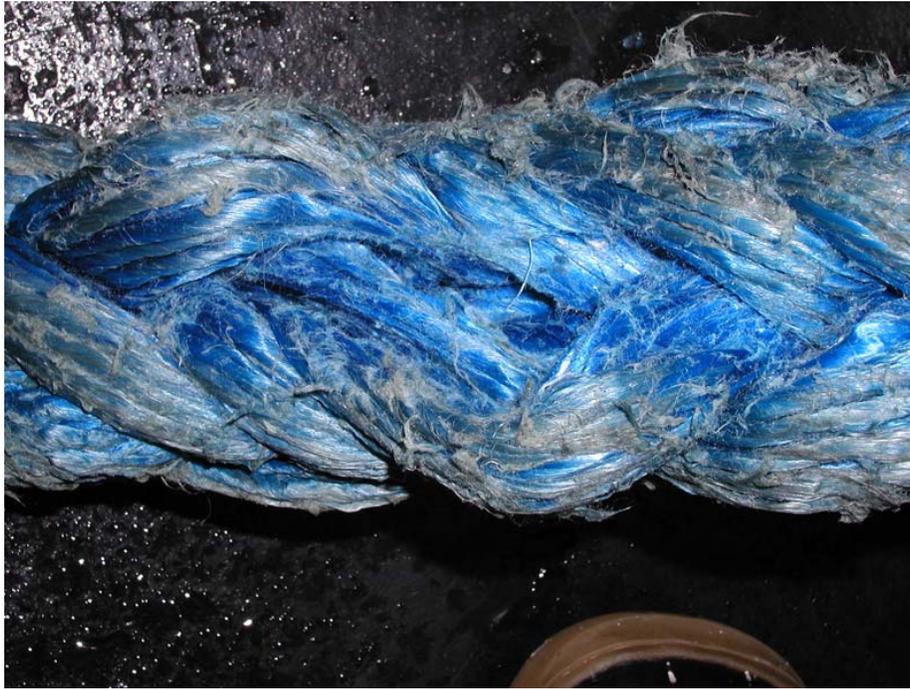
Figure 5 - Fused yarns, should be inspected further

An important note regarding inspecting the internal condition of HMPE towlines; melting and fiber fusing can sometime appear to be much more severe than it actually is. When HMPE towlines are severely overloaded the strand-on-strand compression can cause the fibers and yarns to fuse together as a result of the internal heat and pressure that develop. However, high loads from typical use can create fiber compression with a similar appearance. Figure 5 shows a the condition of an overloaded line with yarn and fiber fusing.

If the yarns and strands can be manipulated by hand and loosened to the fiber level, back to their original condition, the line has not suffered significant damage. However, if the yarns and strands have been permanently fused together this is a sign of severe damage and this section of the line should be repaired or replaced.

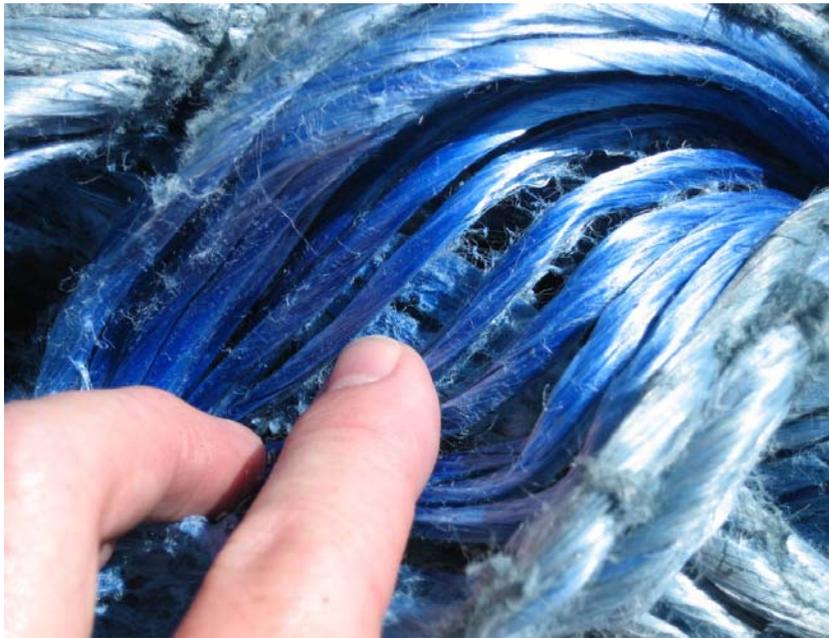
Figure 7 - Internal wear on standard 12-strand pendant

Figure 6 shows the internal condition of a typical 12-strand HMPE towing pendant after several months in service. Notice the wear/fuzzing that has started on the yarn level. Comparing this with the 12-strand pendants with the improved coating there is a significant reduction in yarn-on-yarn damage as shown in Figure 7.

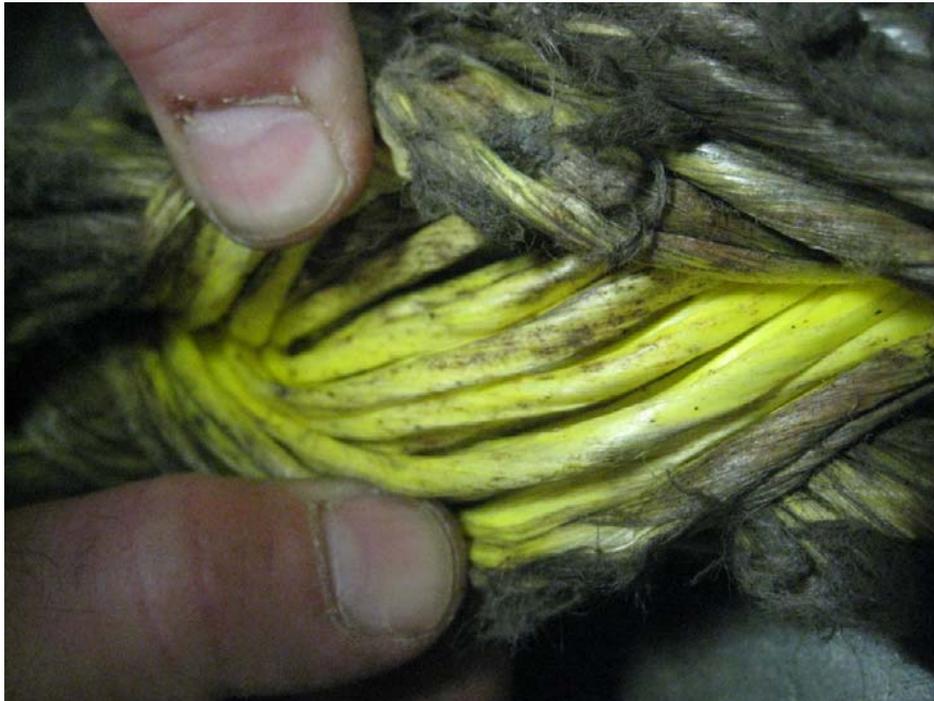
Figure 8 - Internal wear on 12-strand pendant with improved coating

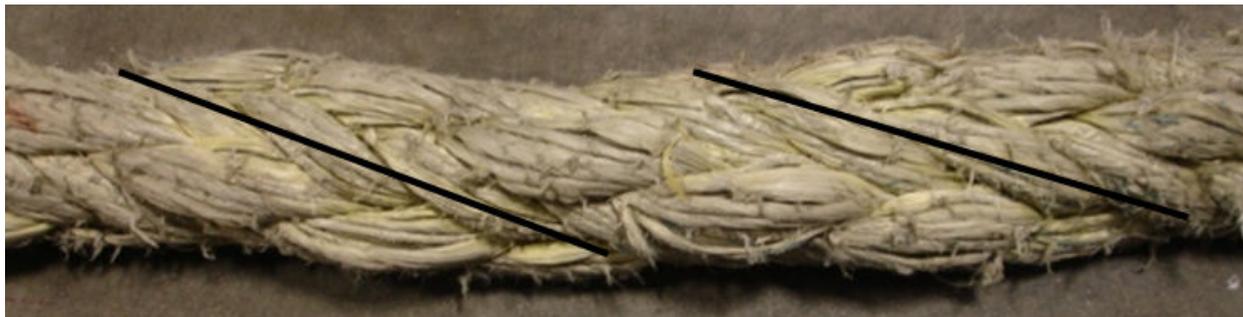
Figure 10 - Twist imparted in HMPE pendant

Figure 9 shows a pendant that has a moderate amount of twist permanently imparted into it from operational influences. The lines in the photo show how the braid pattern has been twisted (strand crowns should run parallel with the axis of the rope). This issue can often be quite difficult to notice in the field, which makes it critical that crew members are aware of the impact it can have so that measures can be taken to prevent permanent twist build up. This can be accomplished by removing twist as lines are taken up after each job/service period.
